Thinking in Acquisition Age

– GW PV Plant Results Analysis

TÜV NORD GROUP

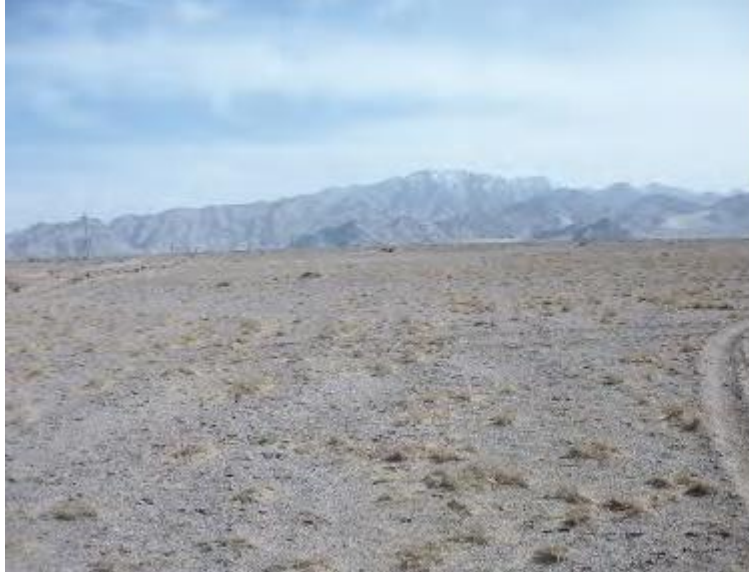
Before installation

The environment issues need considered, especially for the installation of PV plant in western China, when the soil is too vulnerable and hard to recover.

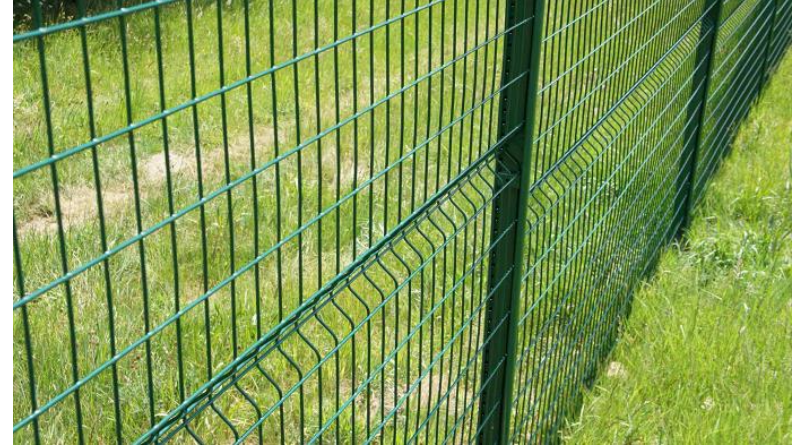
Fence protecting from wildlife

Animal damage

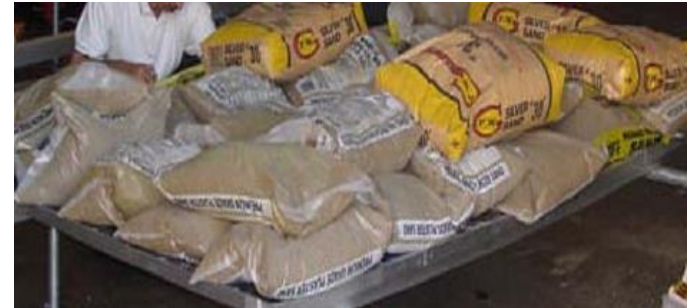
Sand Bag Loading test

- Design load according to extreme wind load and snow load

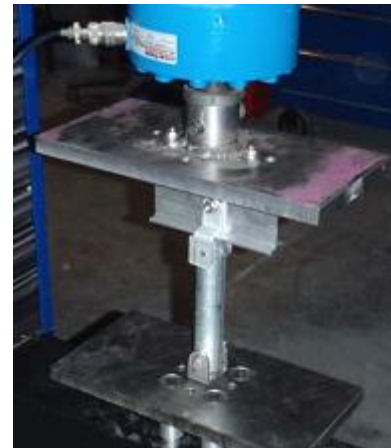
Acceleration test

- Simulate force on different directions
- Consideration of acceleration and duration due to load

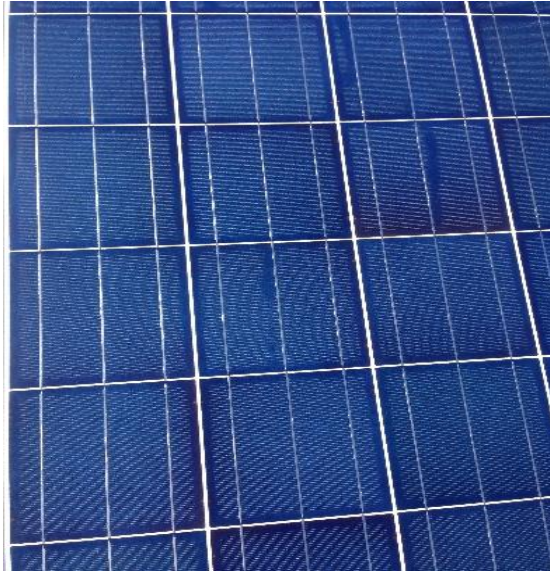
Snail Trail

Snail trail is more and more common to find on-site for the PV system operation after 6 months.

Some institute has declared that they have invented the test method to produce the snail trail. But you need to think about the repeatability.

TC200 + DH + HF + OD

No obvious power degradation occurs
No significant discolored area enlargement

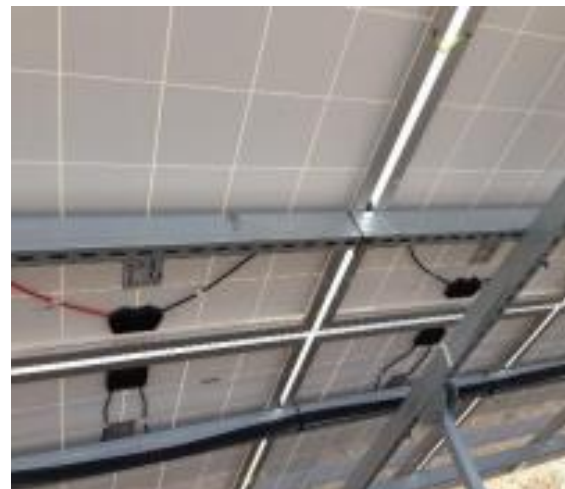
Deviation between design and construction

Deviation between procurement and installation

It is late to find it on-site.

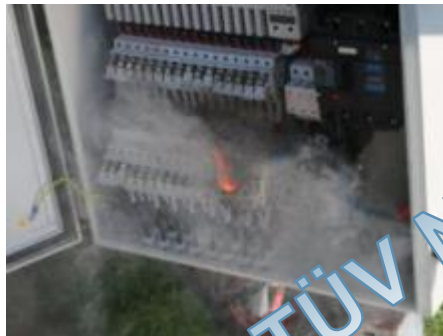
IR Camera Inspection

From **121,500** PV modules, CB, Connections

Average Hot-spot Rate: **0.43%**

Best PV plant: **0.023%**, LSPV 50MW+, 25000 Modules 😊

Worst PV plant: **10.25%**, Rooftop 20MW, 1600 Modules ☹️

One CB Failure ☹️

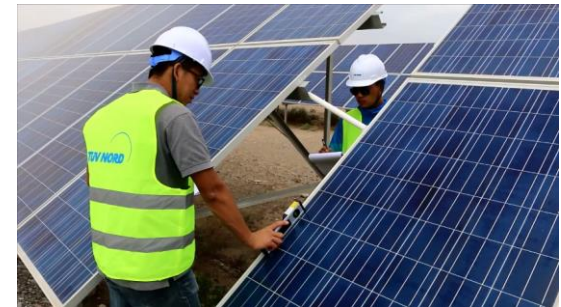
Energy Yield Review

Detailed solar assessment

Loss factor analysis and calculation of Performance Ratio (PR)

Monthly breakdown of P50 forecast

Shading analysis

P50 and P90 production forecasts and annual degradation estimate

Annual variation and uncertainty analysis
